Fireline Rehabilitation on Donnelly Flats fire (B222)  
Summary: 7/1/99 R.R. Jandt

### SUPPRESSION REHABILITATION OPTIONS FOR B222

Prepared 6/24/99 R. R. Jandt, Alaska Fire Service

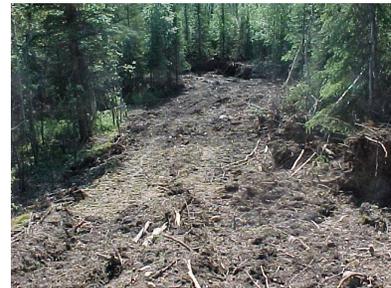
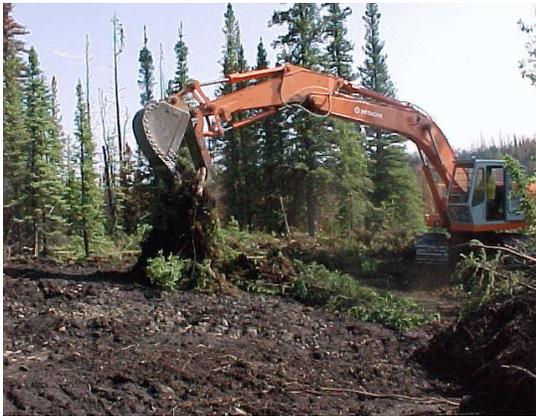
Figure 1:  
Section of wet dozer line, south of 12-mile crossing, before and after treatment using excavator.

Sections of fireline treated with heavy equipment were covered to about 75% with replaced berm material. The excavator was particularly effective where precision work was required, such as leaving winter travel corridor in a trapline trail which was bulldozed, and in moderately wet sections (Figs. 1, 7, 8). Where the line is dry enough for it to work from the middle (person sinks in <2") it effects no additional damage to surrounding vegetation. The bulldozer has long been used to rehabilitate bladed firelines, and works 3 to 4 times faster than the excavator. Resulting cover is similar. One

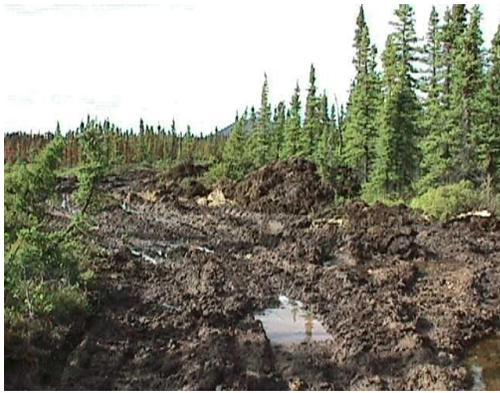
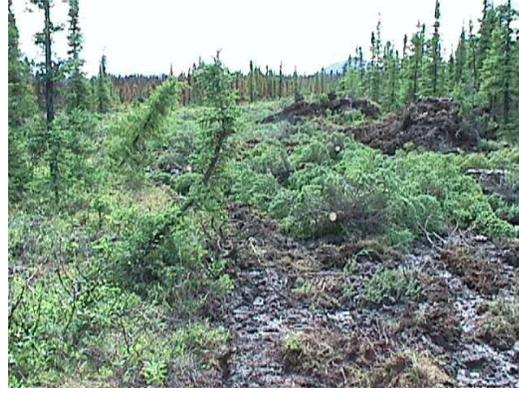
Figure 2. Comparison of bulldozed fireline rehabilitated using hand crews. Photopoint 1, view south on fireline, before and after treatment (63 52.410 x 145 43.472).

Only one section of line, approximately 0.25 miles long, required treatment by hand crew (Fig. 2-6). This area had water standing 2' deep in places, and some water flow, although the grade was mild (<3%) (see map). The crew cut tundra blocks from the berms and cut small trees

from the berms and surrounding forest to scatter on the line for shading and silt entrapment, as well as making drainage trenches where possible. Most of the water on the line was flowing from the watershed above the line with seasonal melt and rainwater, and water was flowing out of the burned areas and onto the line. About 25-50% cover was achieved on this section of line. Photopoints were established. A significant reduction in standing or flowing water was noted between the day before treatment and a week later.

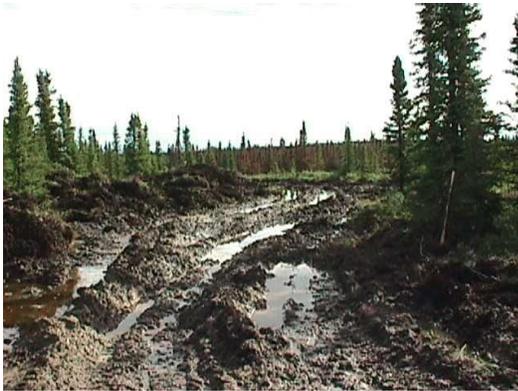
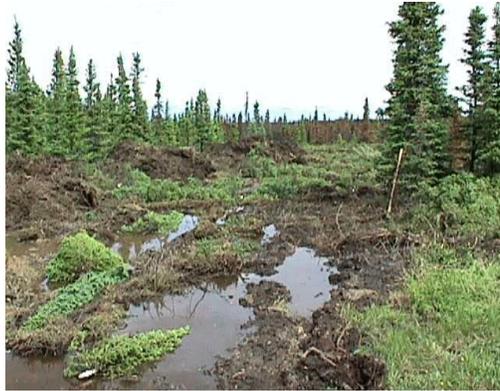
Figure 3. Comparison of bulldozed fireline rehabilitated using hand crews. Photopoint 1, view north on fireline, before and after treatment (63 52.410 x 145 43.472)

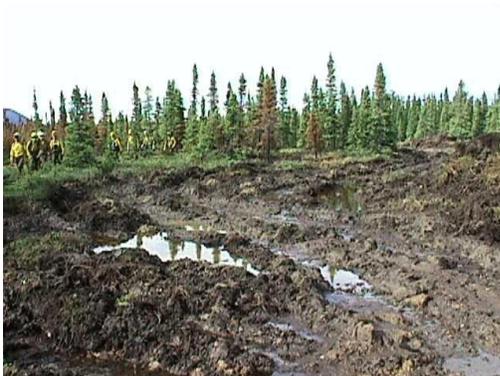
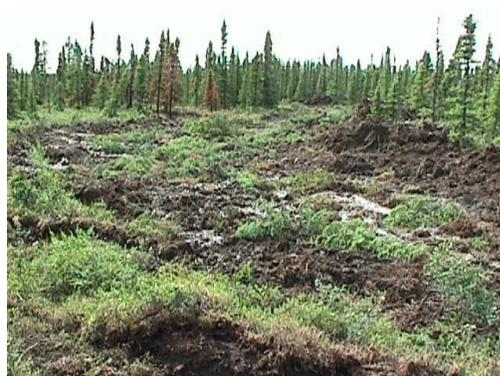
Figure 4. Comparison of bulldozed fireline rehabilitated using hand crews. Photopoint 2, view south on fireline, before and after treatment (100m N. of PP1, 63 52.432 x 145 43.423).

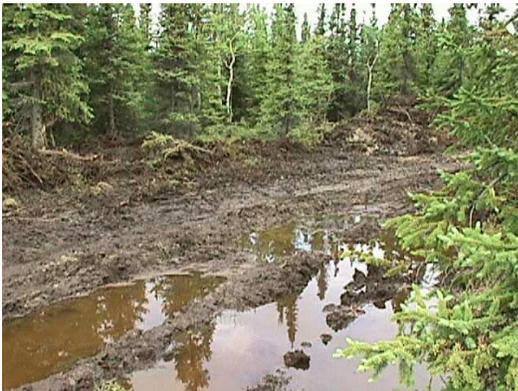
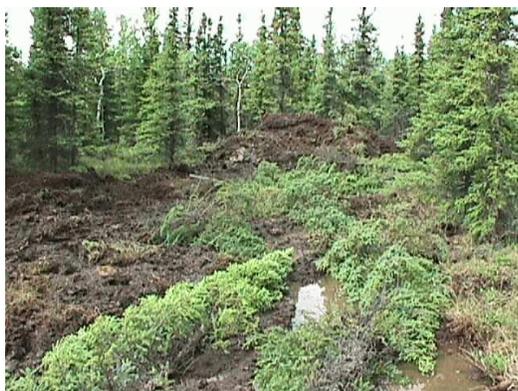
Figure 5. Comparison of bulldozed fireline rehabilitated using hand crews. Photopoint 3, view northwest on fireline, before and after treatment.

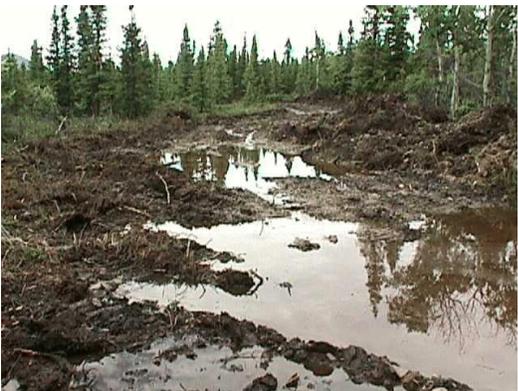
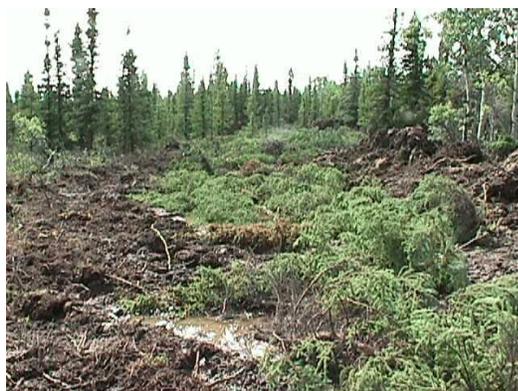
Figure 6. Comparison of bulldozed fireline rehabilitated using hand crews. Photopoint 4, before and after treatment.

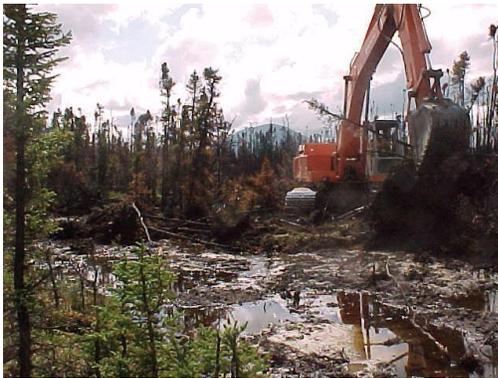
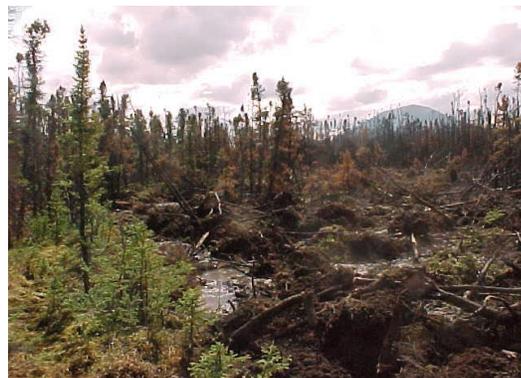
Figure 7. Comparison of section of bulldozed fireline before and after rehabilitation using excavator. This line burned over 2 weeks previously; frost in ground had receded 2.5 ft. The equipment worked off the line from the berm side, so that it would not sink in the mud.

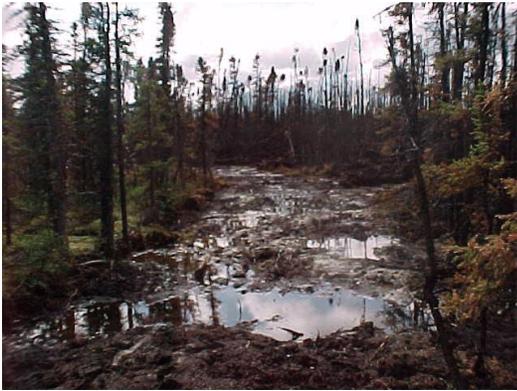
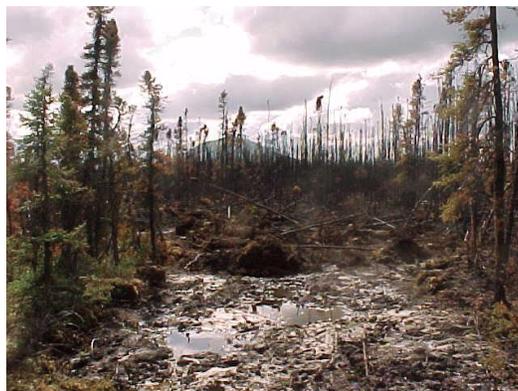
Figure 8. Comparison of section of bulldozed fireline before and after rehabilitation using excavator. This line burned over 2 weeks previously; frost in ground had receded 2.5 ft.
