CC1 Site Assessment Survey

Quad Name _____ Lat 64 19.828' TWN/RNG/SEC _____
 Quad _____ Long 146 56.905' Allotment #42
 Number _____
 Owner Kurt and Carl Lindig Phone 907-460-1971 Permit # _____
 Address 5 Mile Clear Creek

First structure on 5 Mile Clear Creek on river right (looking down river).

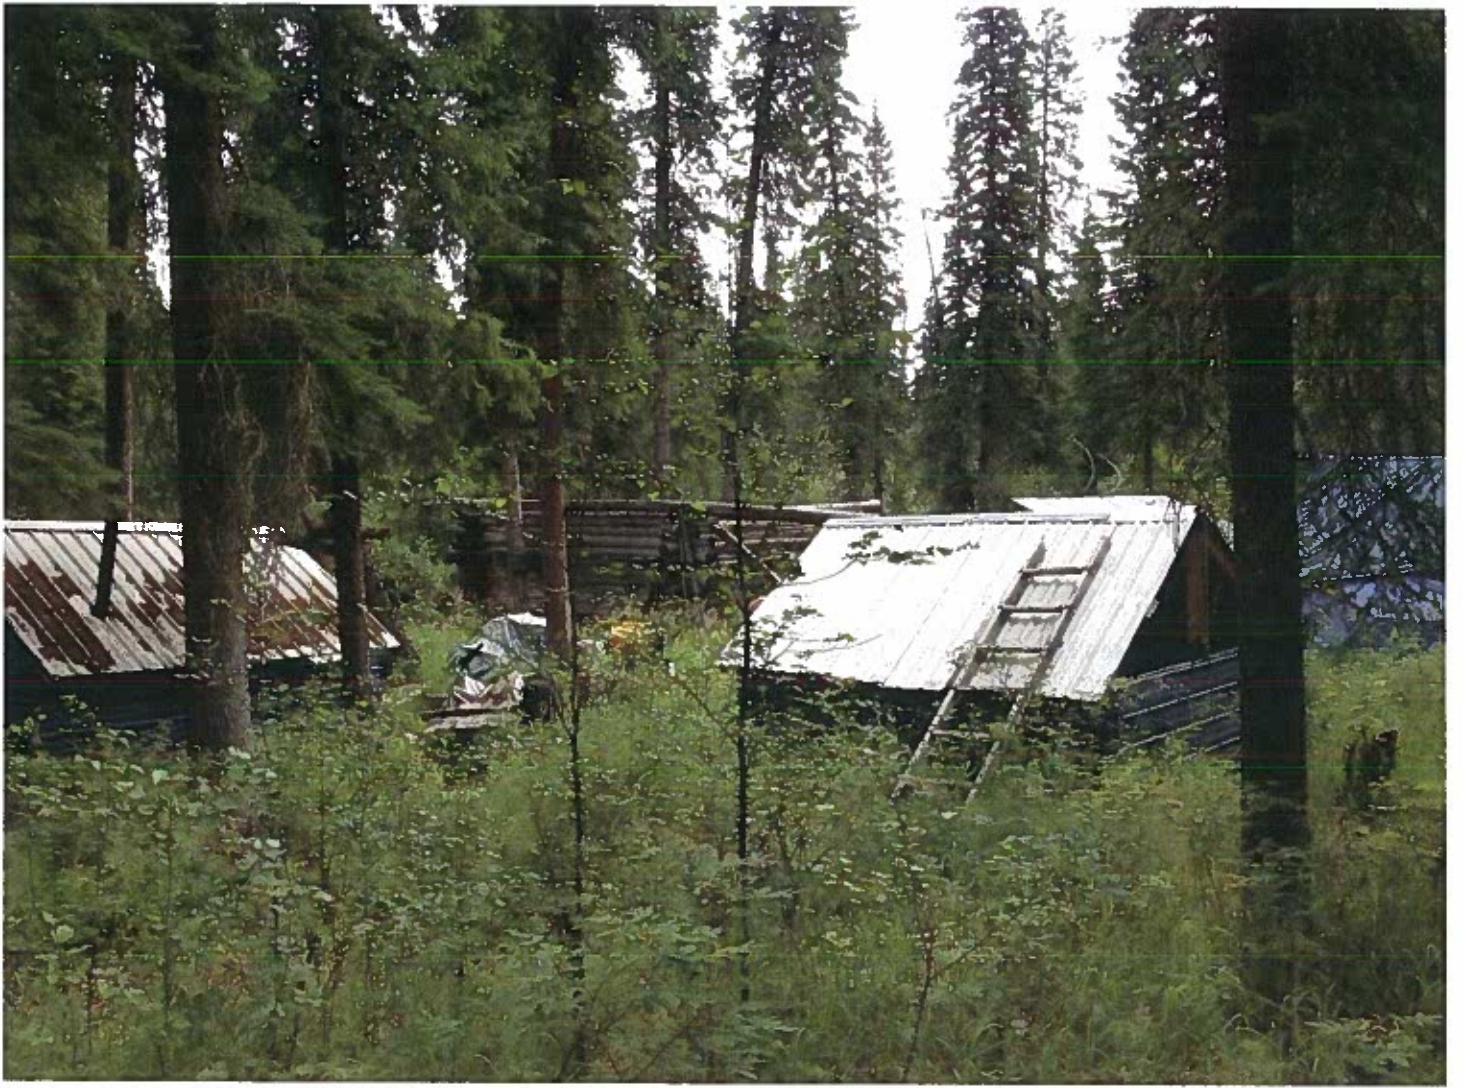
Photo included

3 total structures on site, main cabin, storage shed, outhouse.

3 Total structures on site accessible by boat. Open deck facing the creek. Black Spruce has been thinned by 1 chain around the main structure. Two sprinkler kits have been set up, ran by 1 mark 3.

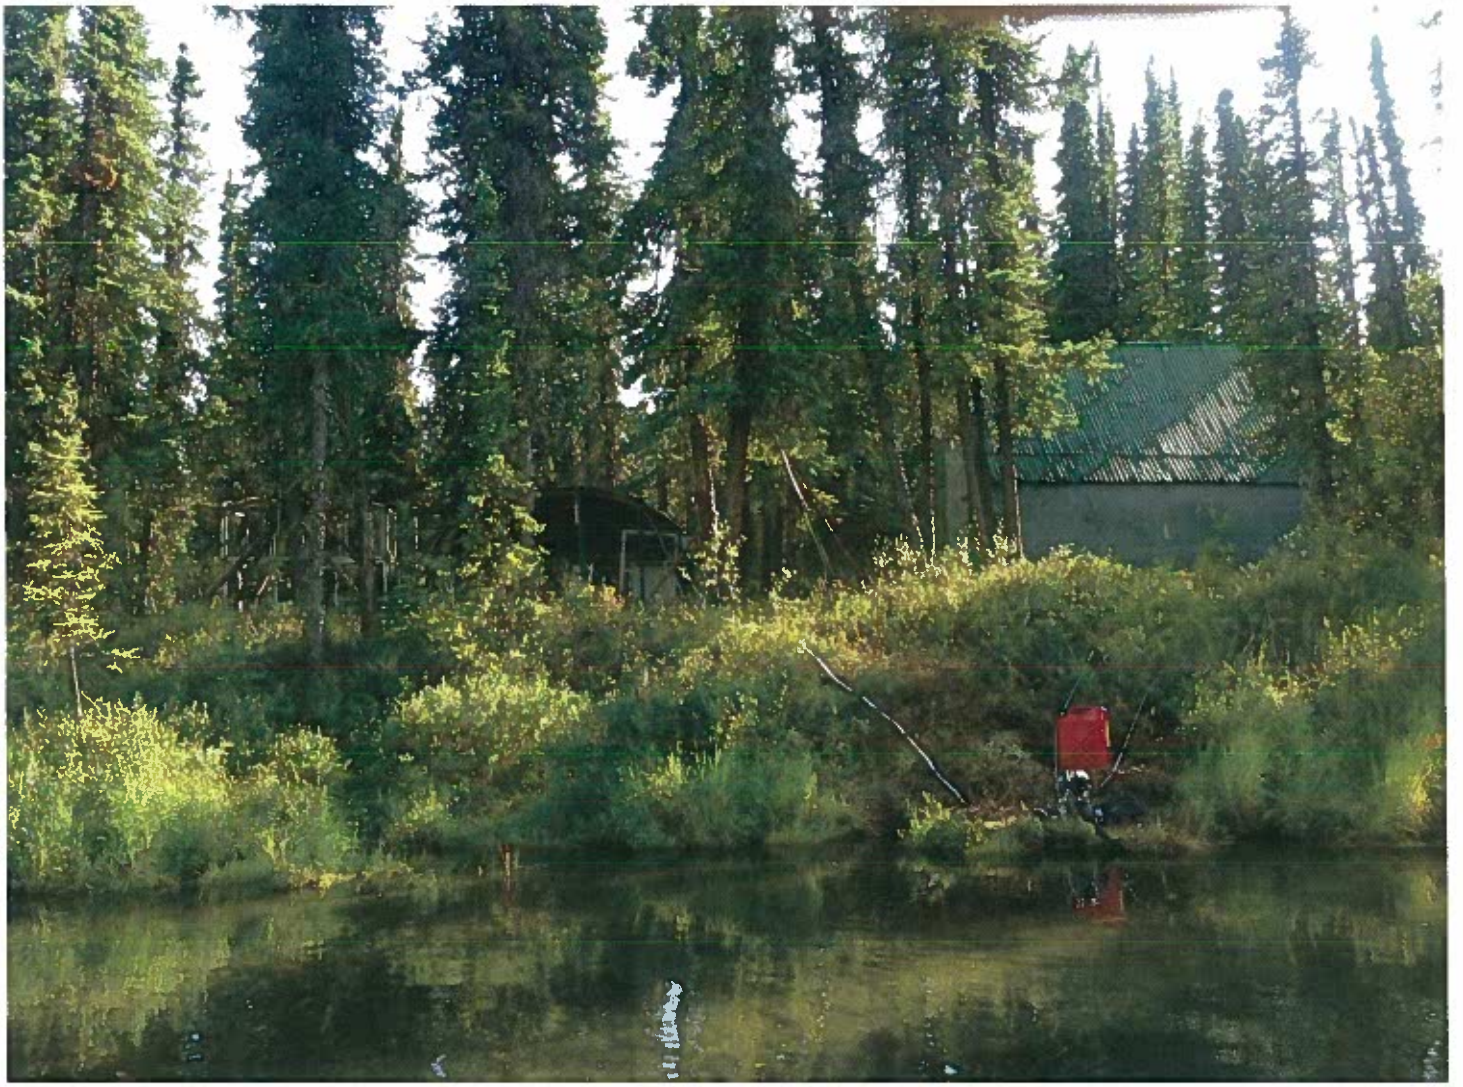
2 total structures on site, Quonset hut, green house.

2 Total structures on site accessible by boat. Black Spruce has been thinned by 1 chain around the main structure. One sprinkler kit has been set up, ran by 1 Shindaiwa.

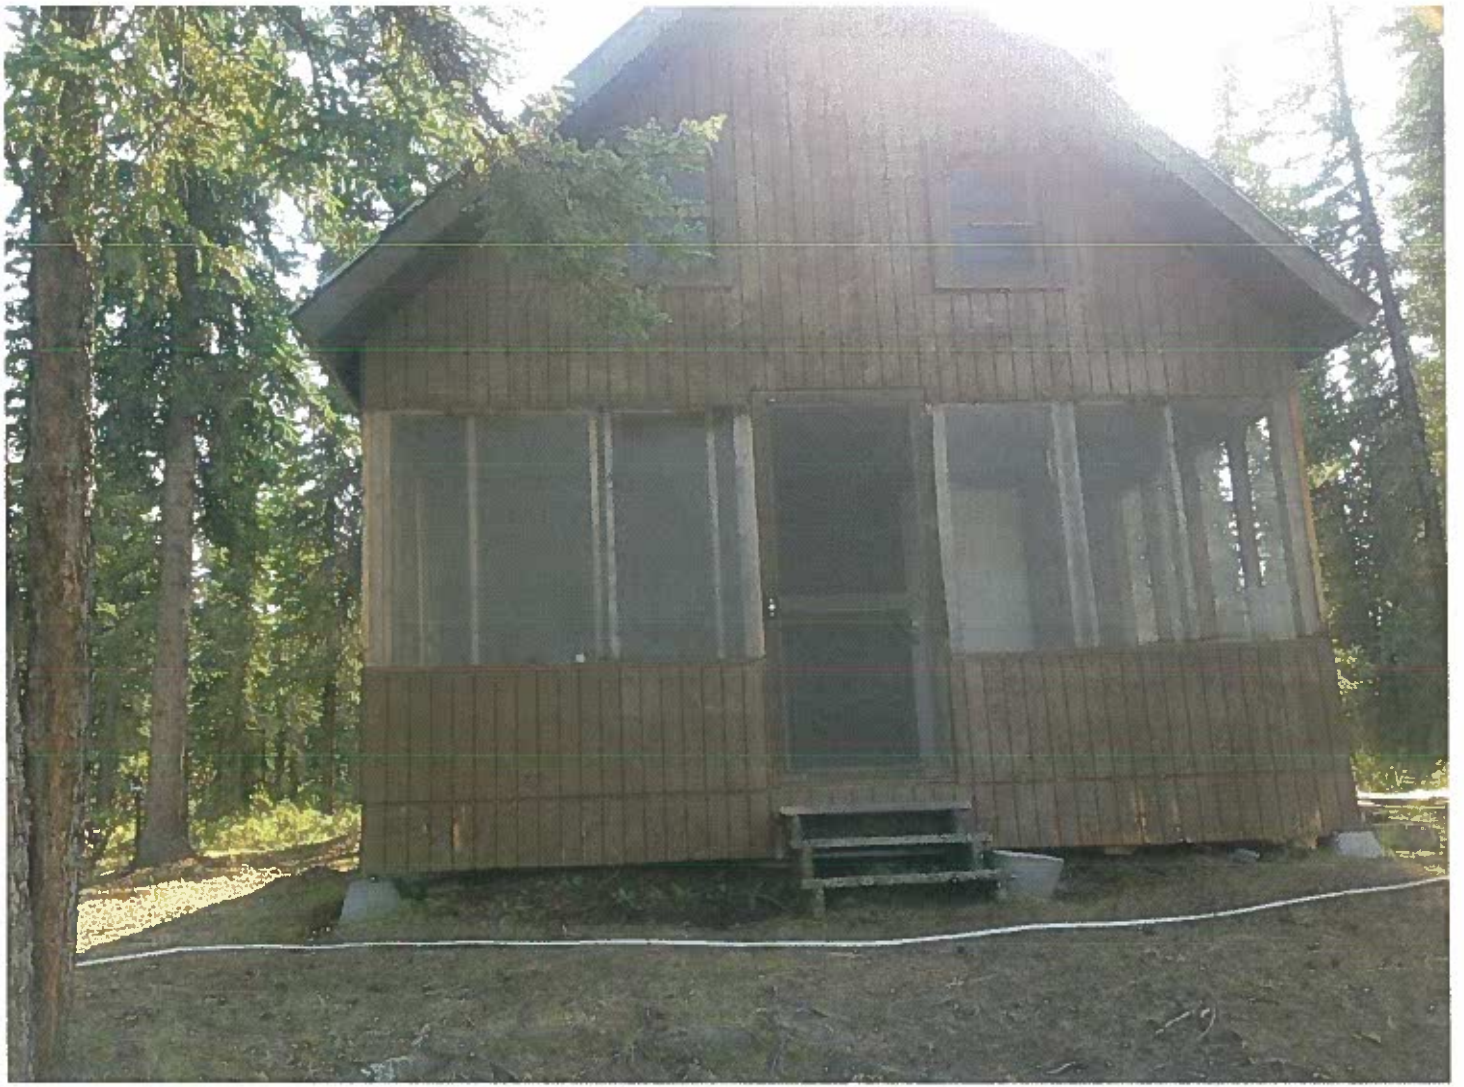
2 total structures on site, cabin, out house. Wooden construction with metal roof and screened-in porch.

2 Total structures and wooden dock on site accessible by boat. Black Spruce has been thinned by 1 chain around the main structure.

One sprinkler kit has been set up, ran by 1 Shindaiwa.

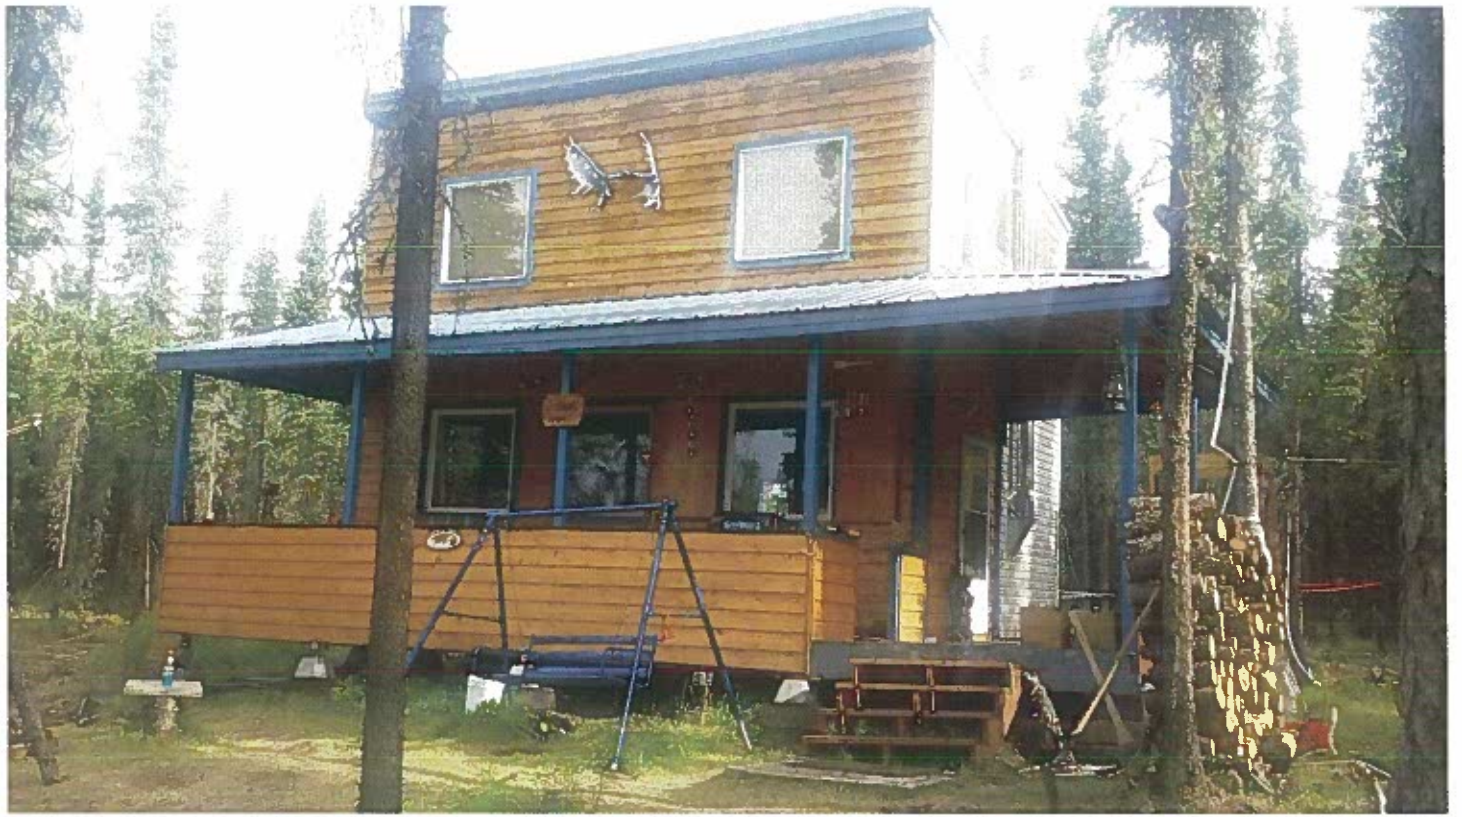
Fourth structure on 5 Mile Clear Creek on river right (looking down river).
 3 total structures on site, main cabin, storage shed, outhouse.
 Wood construction with blue trim

3 Total structures on site accessible by boat. Open deck facing the creek. Black Spruce has been thinned by 1 chain around the main structure. Two sprinkler kits have been set up, ran by 1 mark 3.

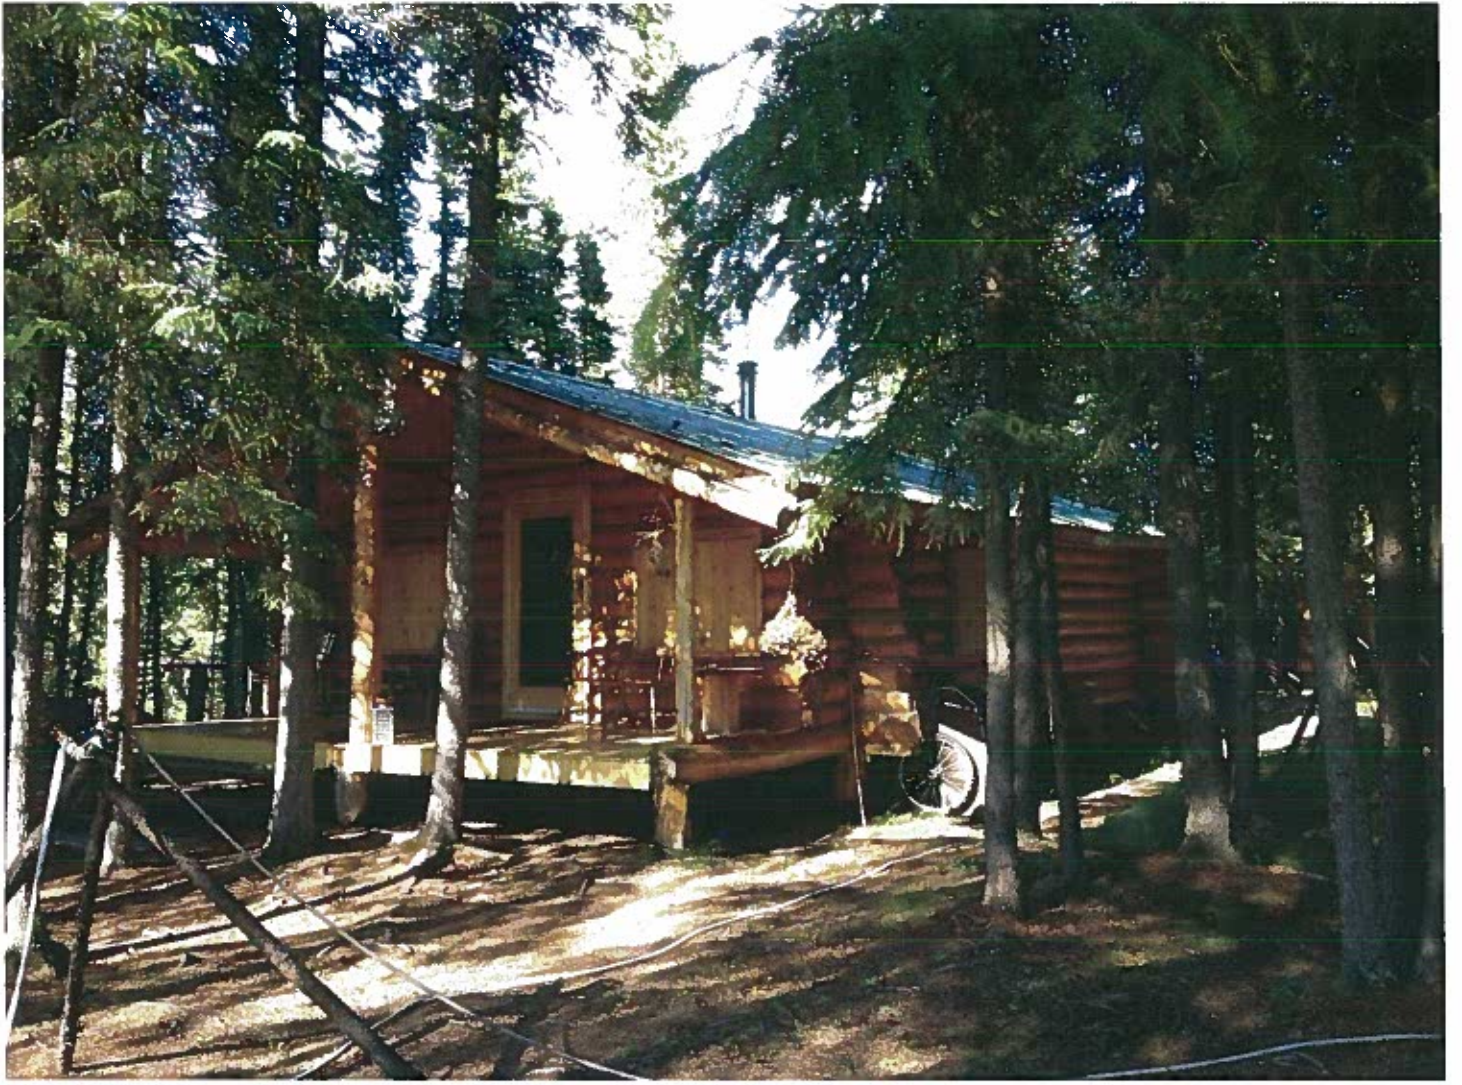
Photo included

6 total structures on site: cabin, out house, fuel shed, generator shed, hot tub and greenhouse. Wooden construction with metal roof.

6 Total structures on site accessible by boat. Several outbuildings tucked into thicker stands of mixed black and white spruce. Black

Spruce has been thinned by 1 chain around the main structure. Two sprinkler kits have been set up; ran by 1 Mark 3 pump.

Black Spruce around the outer periphery of main structure, but fuels immediately around main structure is mature white spruce without ladder fuels and some spacing in the canopy.

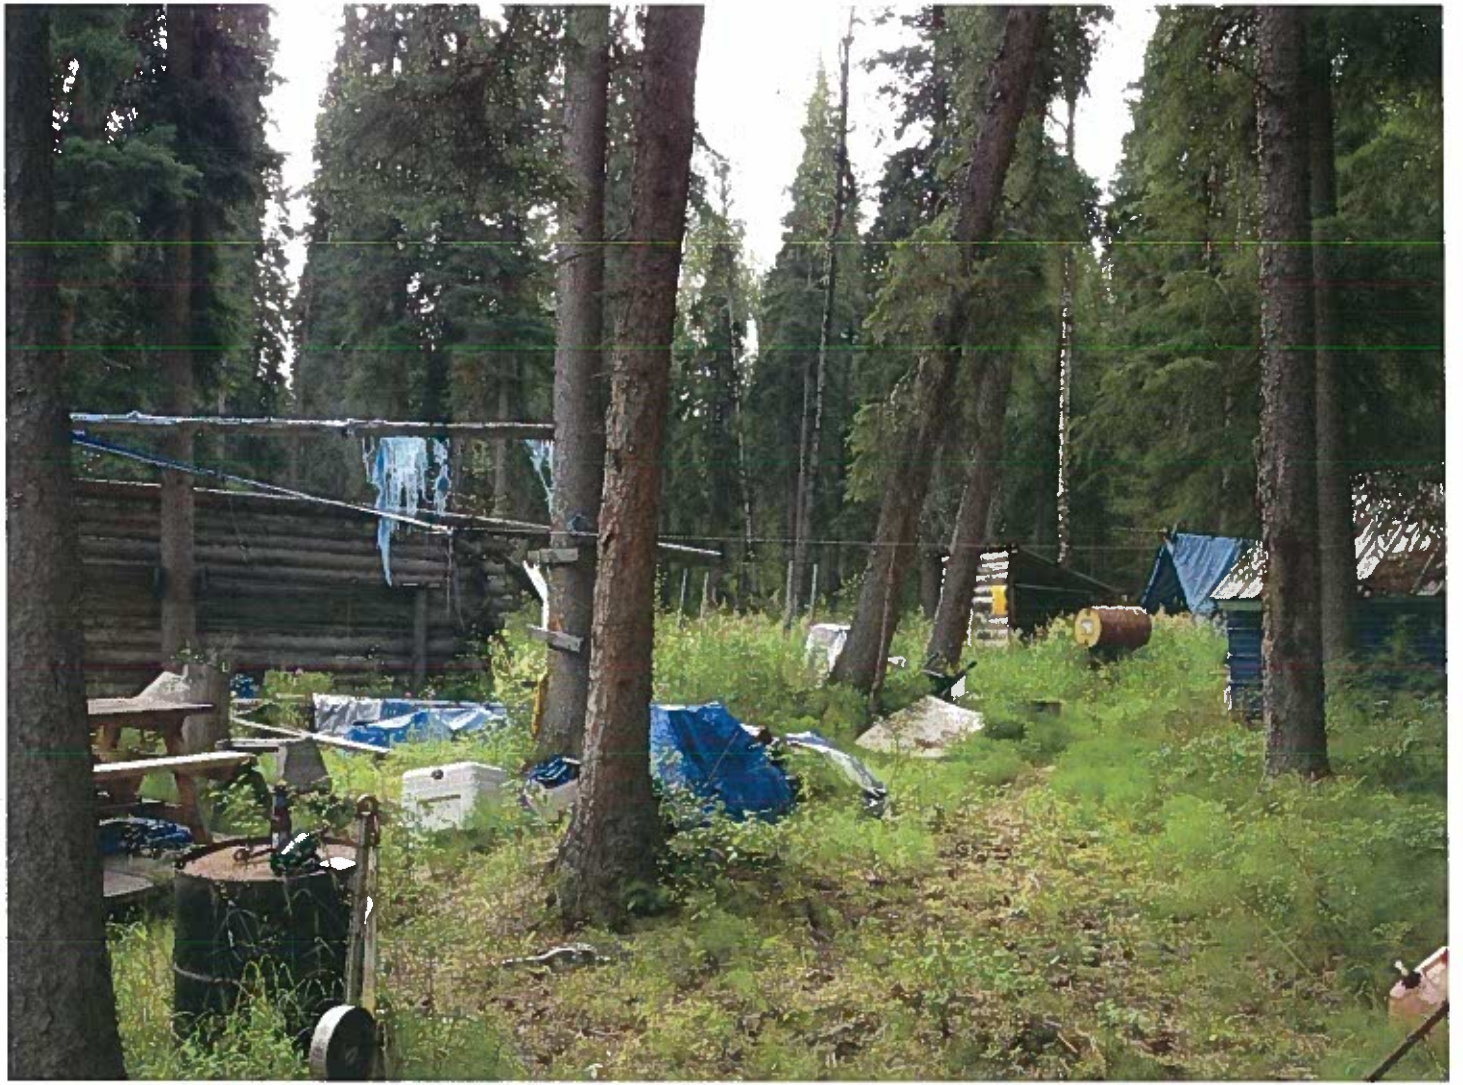
3 total structures on site: cabin, out house and shed. Wooden construction with metal roof.

3 total structures on site, accessible by boat. Black Spruce has been thinned by 1 chain around the main structure. One sprinkler kit has been set up; ran by 1 Shindaiwa pump.

Black Spruce around the periphery of main structure, but fuels immediately around main structure is mature white spruce without ladder fuels and some open spacing in the canopy.

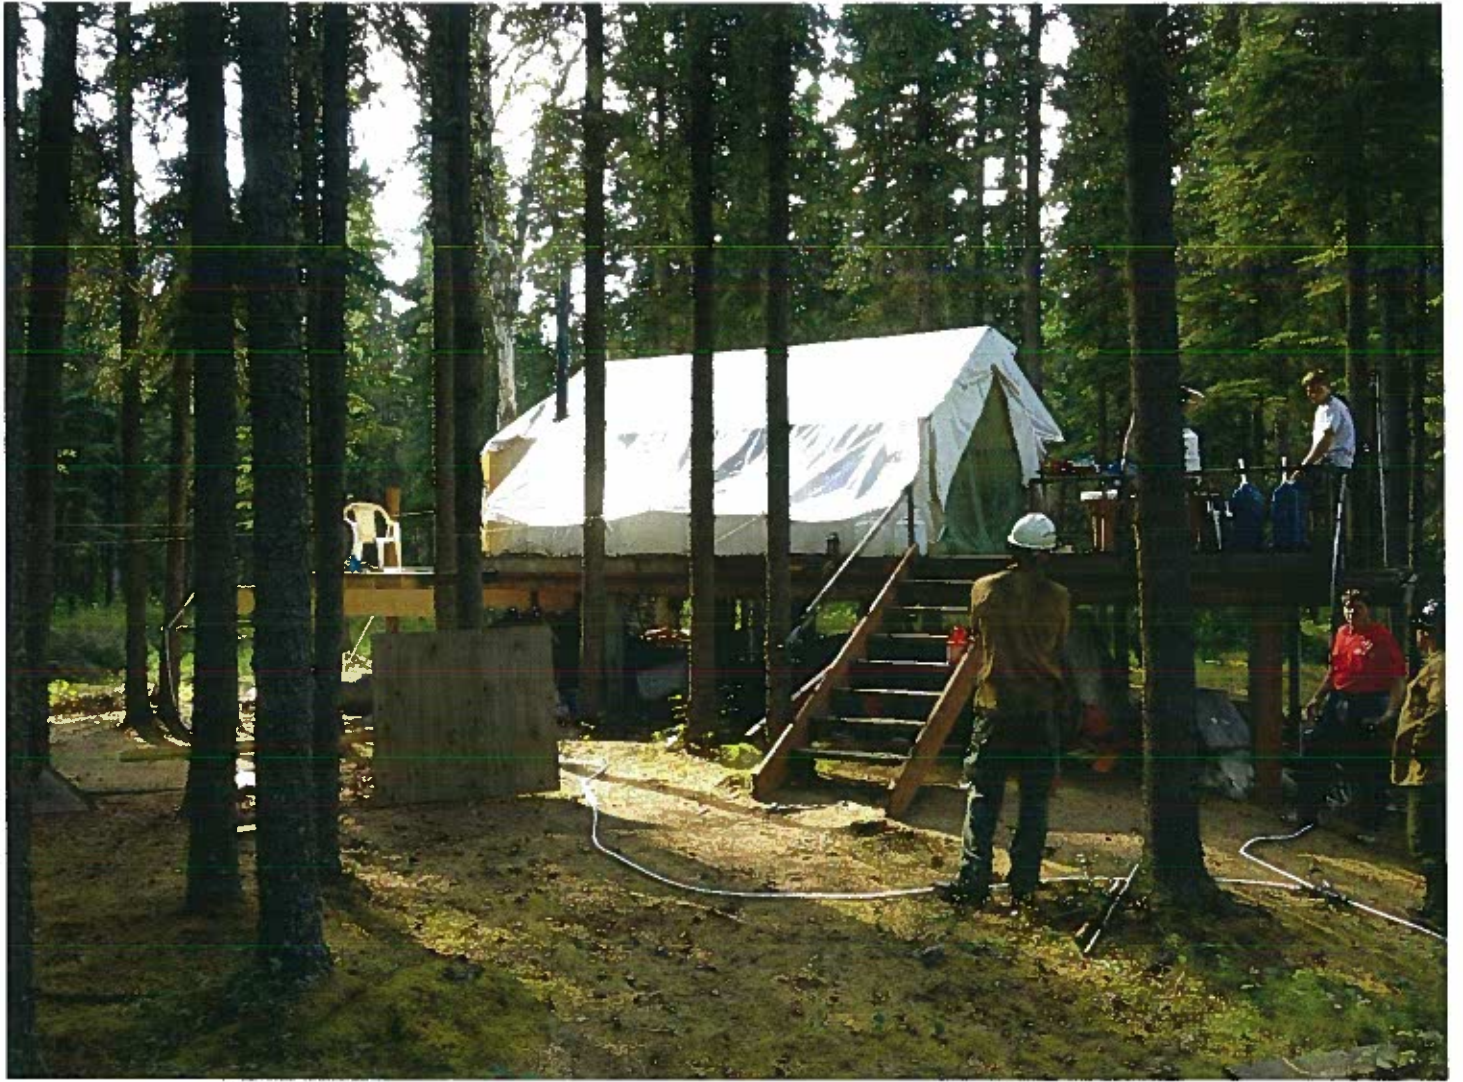
Photo included

1 total structures on site: cabin. Wooden construction.

1 total structures on site, accessible by boat. Structure is a finished platform for a wall tent with spaced planks on top and

miscellaneous items stored beneath. Black Spruce has been thinned by 1 chain around the main structure. One sprinkler kit has been set up; ran by 1 Shindaiwa pump.

Fuels immediately around main structure is mature white spruce without ladder fuels and some open spacing in the canopy. Mostly white spruce around outer periphery with some hardwoods mixed in.
